# Your Inspection Report

25 Lawrence St  
Little Falls, NY 13365

Monday, October 8, 2018

Report No. 1576, v.2

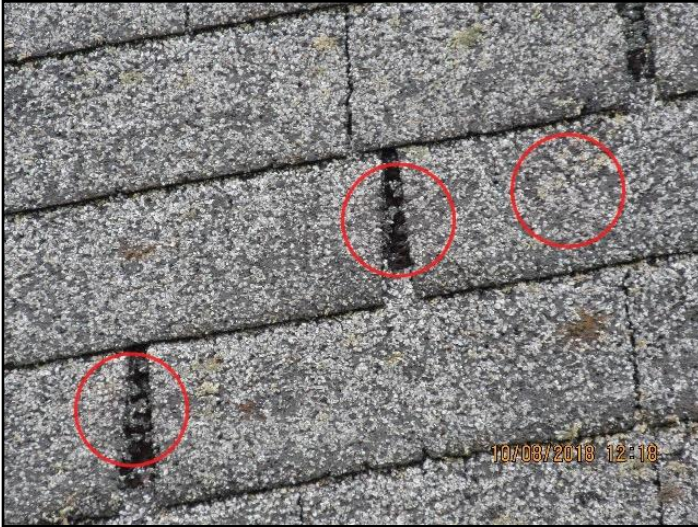
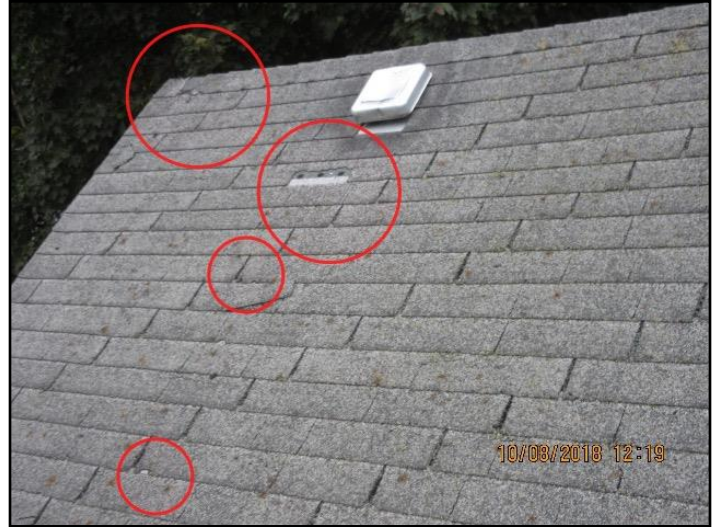
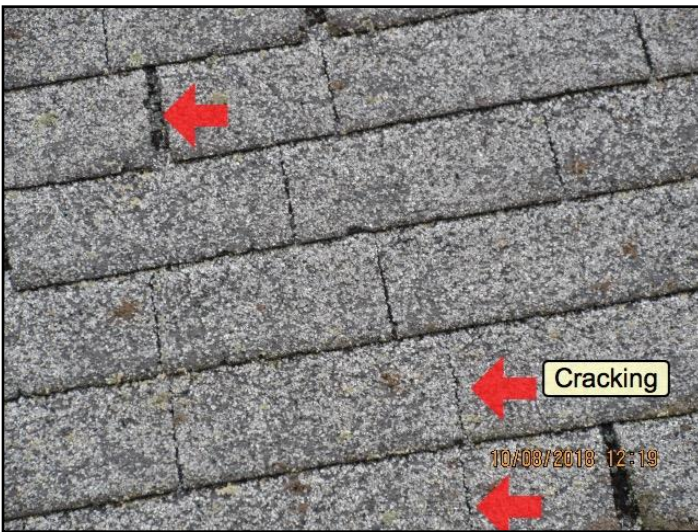
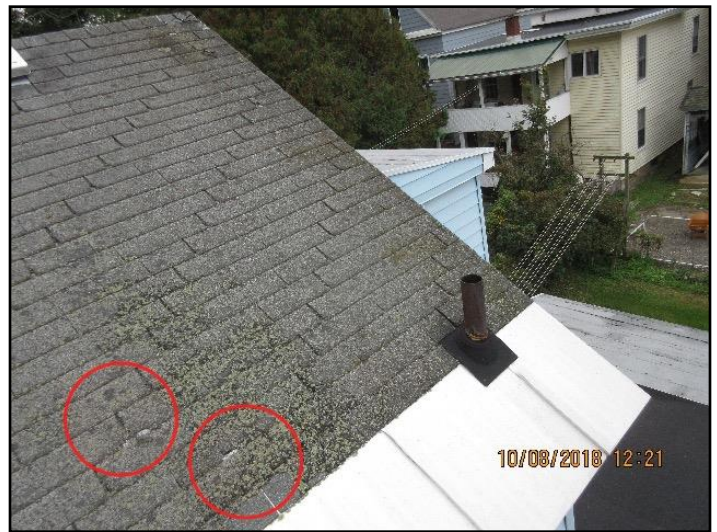
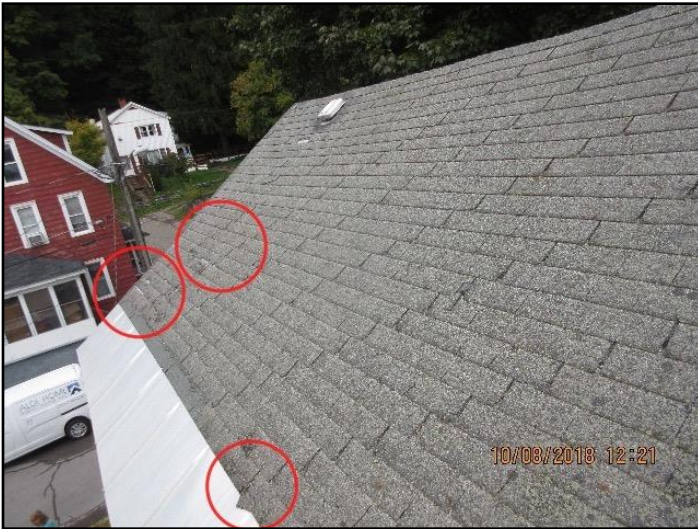
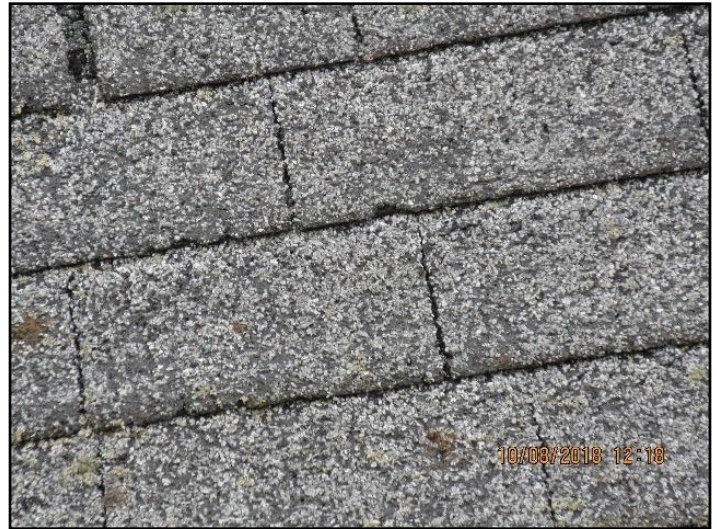
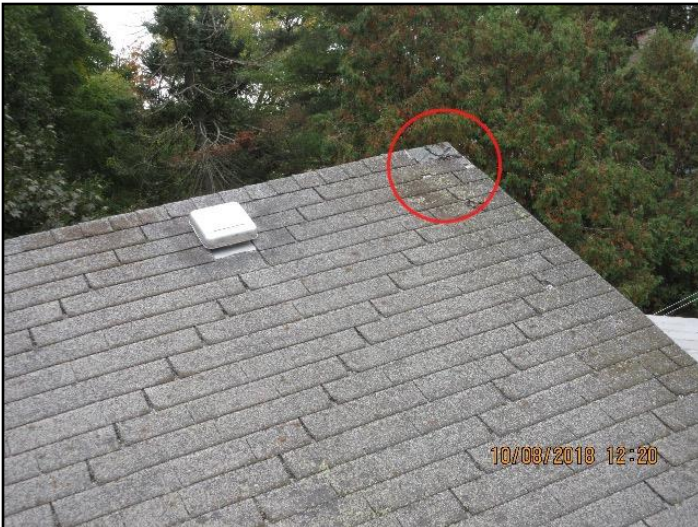
Roof appears to be at/near end of useful life. Observed many shingles which are worn, cracked, damaged, missing and vulnerable to moisture penetration on the right side of the home. Left side of the home had limited observations, However cracking, wear and stone loss was also observed on the left side of the home. Strongly recommend a roofing contractor is contacted to further assess and advise As Soon As Possible.

2. Right Side Old, worn out, Cracking

3. Right Side Damaged/Missing Shingles

4. Right Side Cracking/Wear

5. Old, worn out Damaged Right Side

6. Damaged/worn out Right Side

7. Old, worn out Right Side

8. Right Side Old, worn out/Damaged

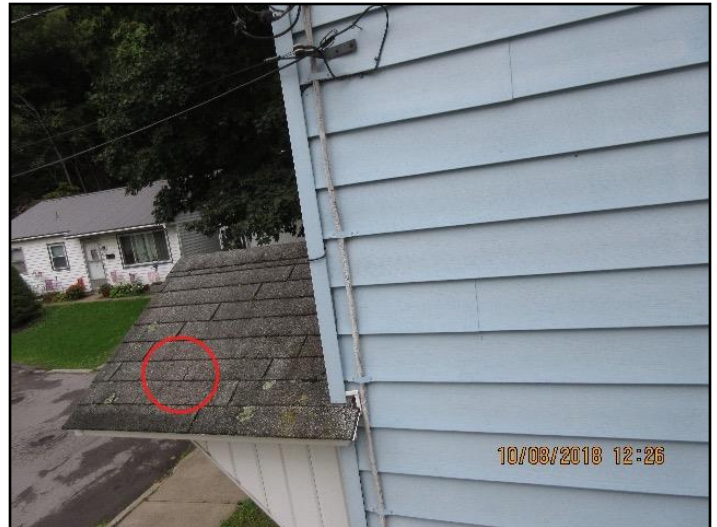
9. Front Porch Cracked

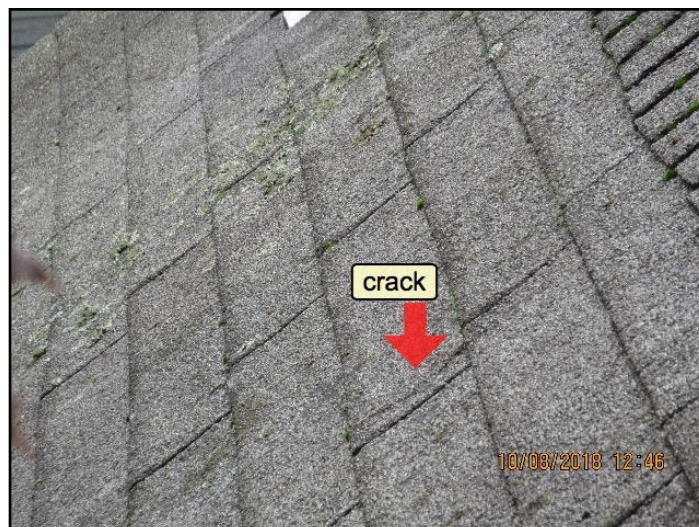
10. Left Side Crack, Stone loss, Worn

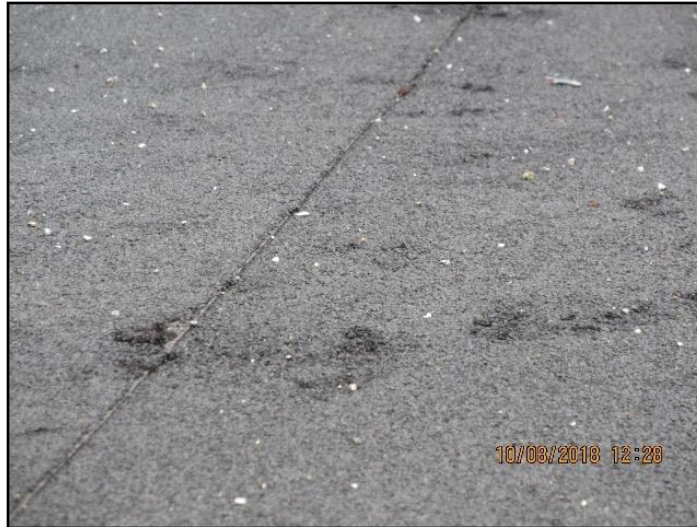
**11. Damage**

Minor: Recommend contacting a qualified roofing contractor to repair.

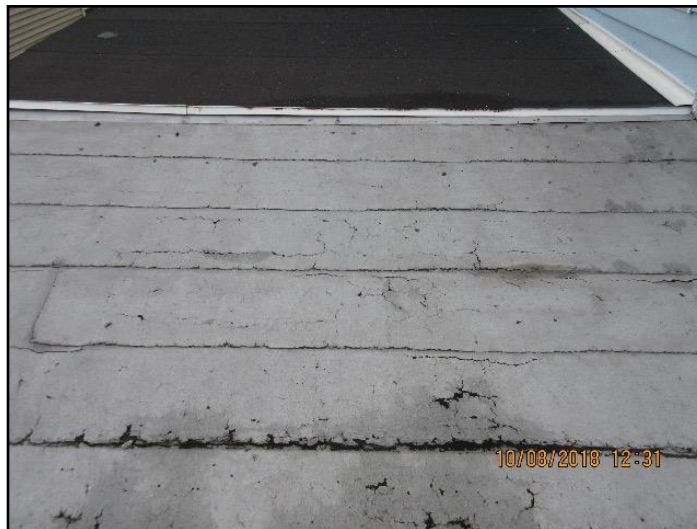
Observed severe cracking and wear over rear enclosed porch. Strongly recommend a roofing contractor further assess the roof and advise cost to repair.

**12. Cracked/Damaged/Worn Out**

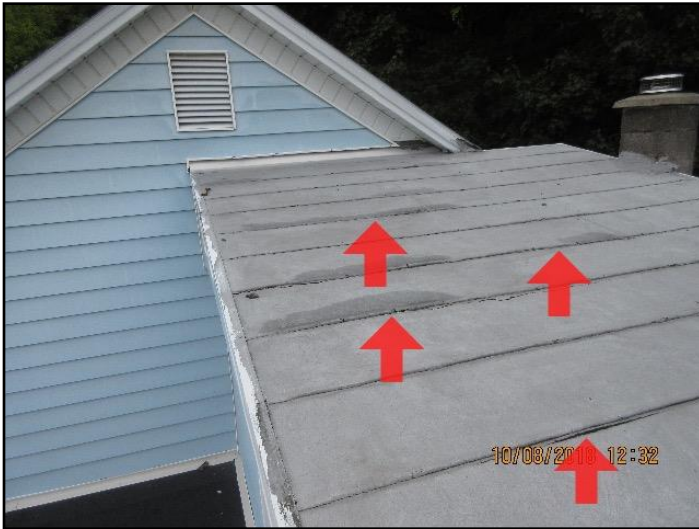
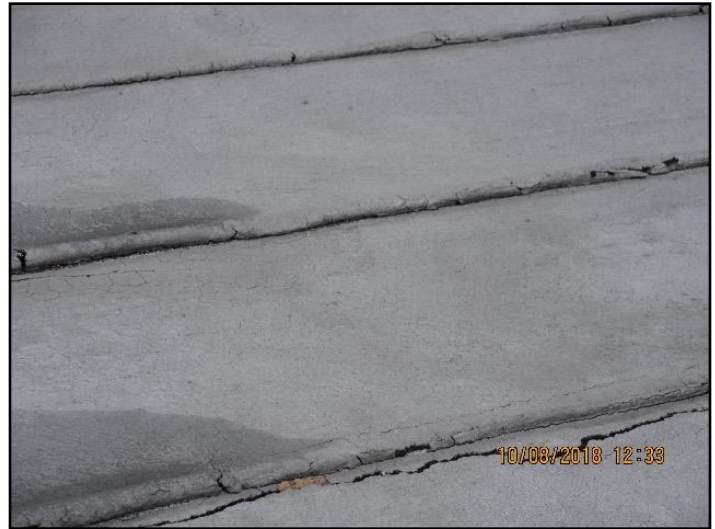
Severe Cracking was observed. Strongly recommend a roofing contractor further assess the roof and advise cost to repair.

13. Cracked

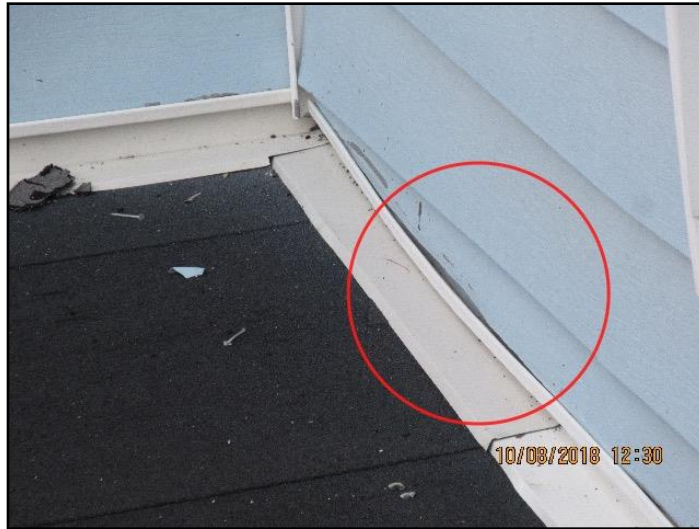
16. Damage, loose, open seams, patched

Vulnerable areas: Recommend client contact a qualified roofer to further assess and advise.

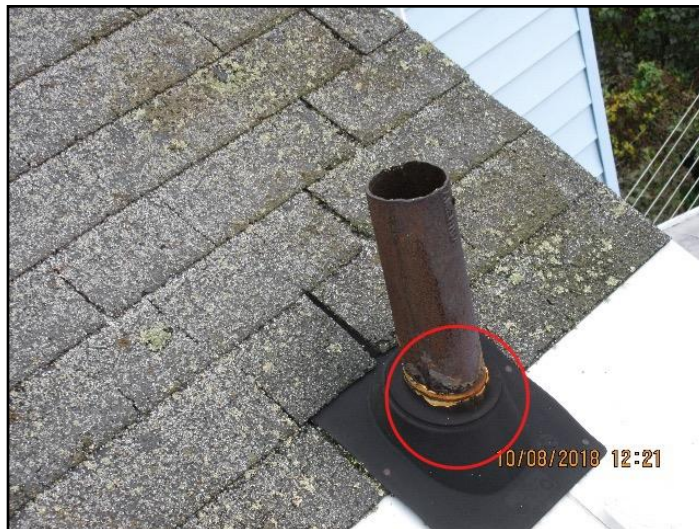
Vulnerable area for water penetration: Neoprene boot is damaged. Contact a roofing contractor to further assess and replace as needed to avoid possible water penetration to interior space.

17. Damage

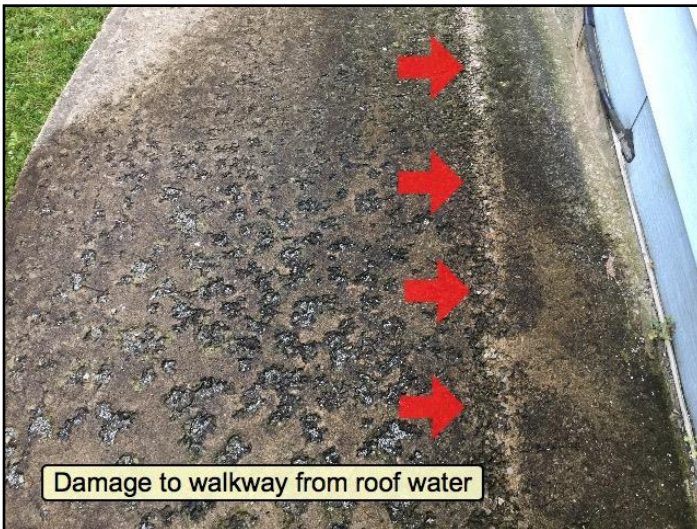
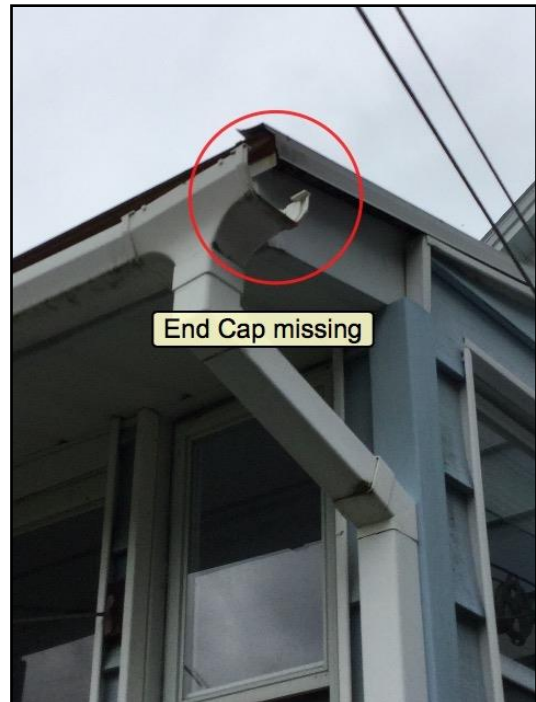
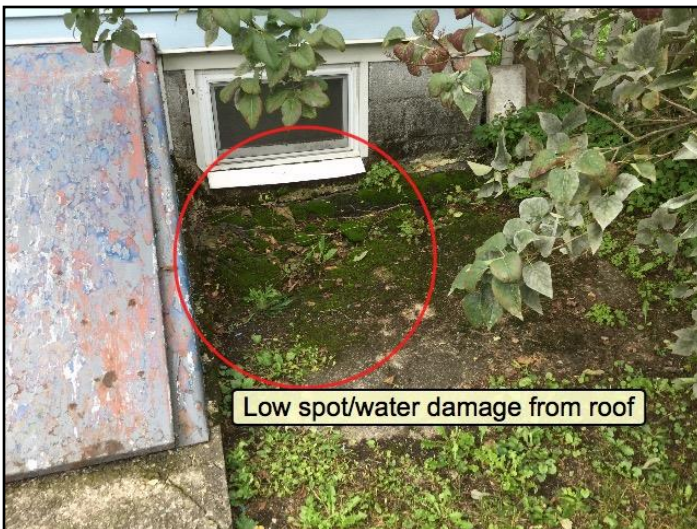
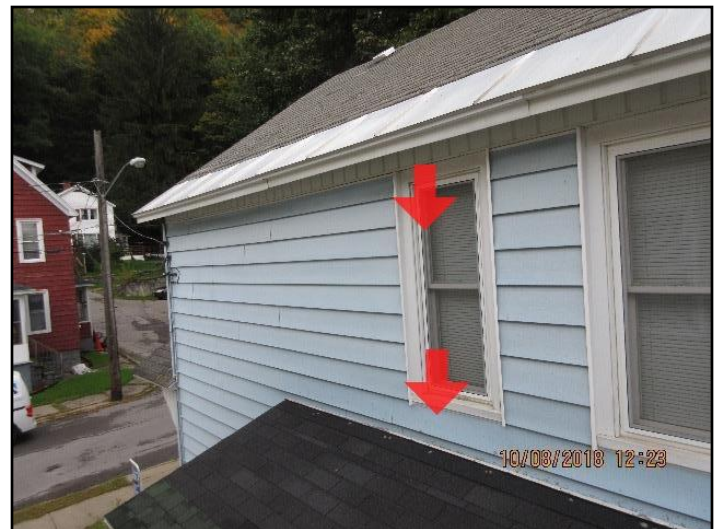
Significant volumes of water are coming off of the roof, onto lower roofs, (shortening roof life) and very close to the foundation. Foundations can be damaged by water discharge from the roof/close to the foundation. Recommend installing gutters throughout and downspouts at least 6 feet in length to evacuate water away from foundation.

Recommend building up soil/sloping away from foundation in low spots. Contact a gutter company to further assess and advise.

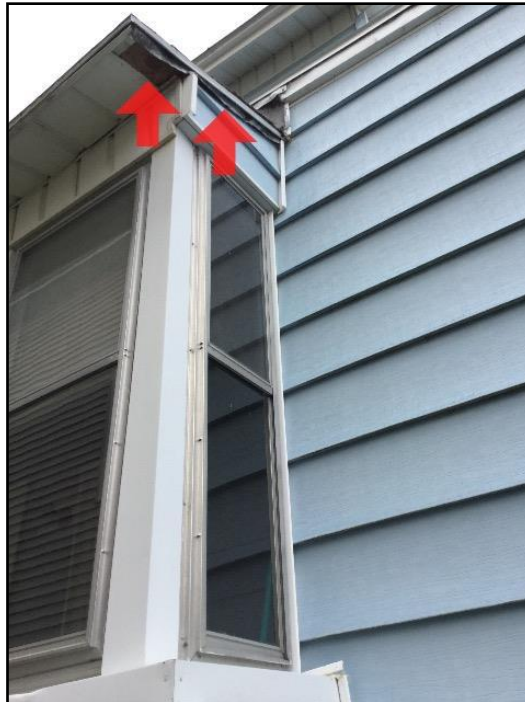
22. Loose or missing pieces

Contact a contractor to further assess and repair.

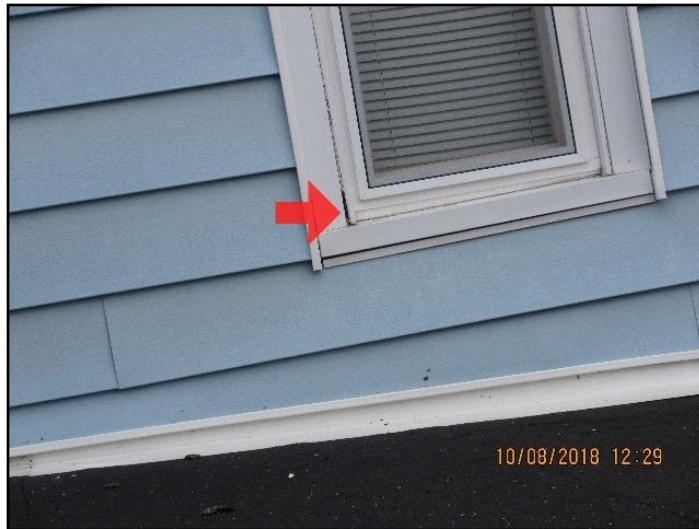
24. Paint and Caulking - deteriorated / missing

Have a contractor seek out and caulk gaps/old shrunk caulk to reduce heating costs and avoid water damage.

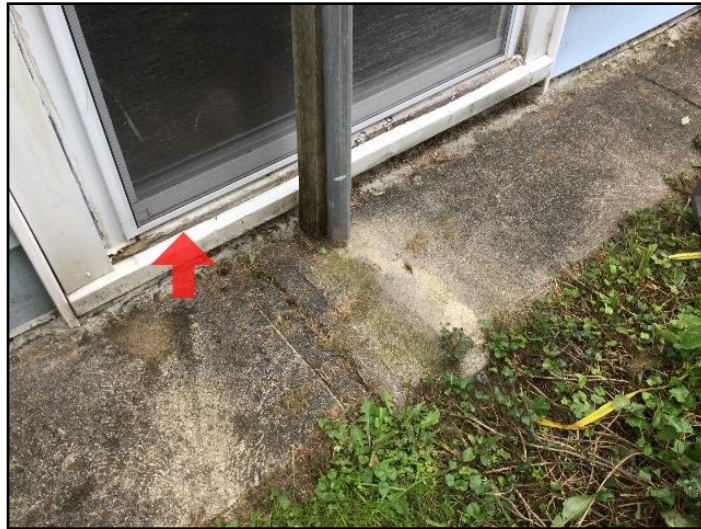
Windows need painting to avoid deterioration of the wood.

25. *Paint or stain needed*

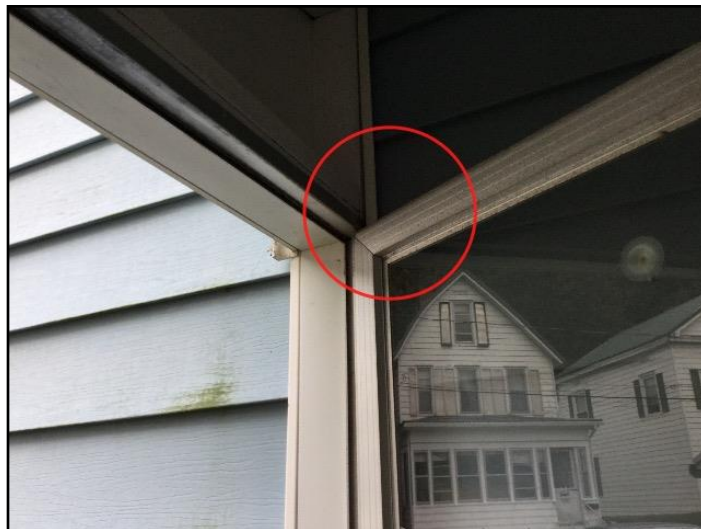
Storm door automatic door control/return assembly is missing/not attached. Recommend having repaired as soon as possible.

26. *Missing*

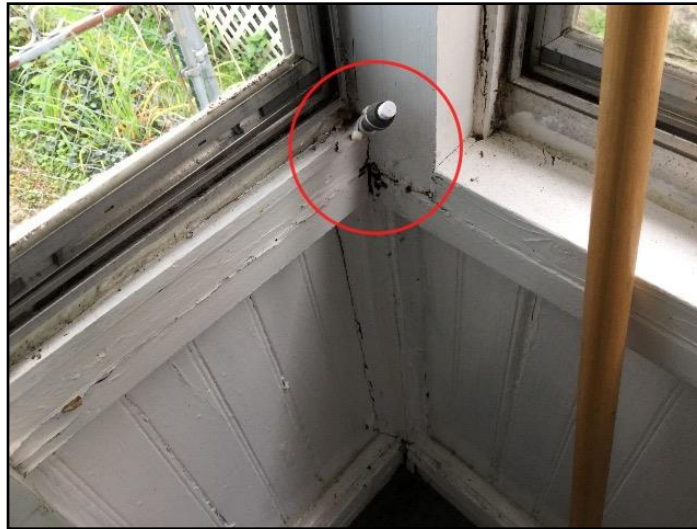
Observed small area of rot on the porch. Have a contractor further assess and repair as needed.

27. Rot

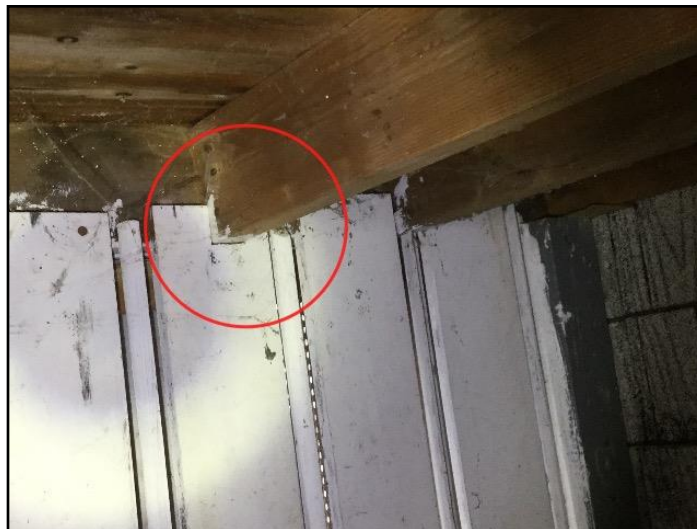
Minor: While the porch appears to be in very good condition, Recommend client have contractor add joist hangers to provide greater strength and stability to porch.

28. Fastener problems

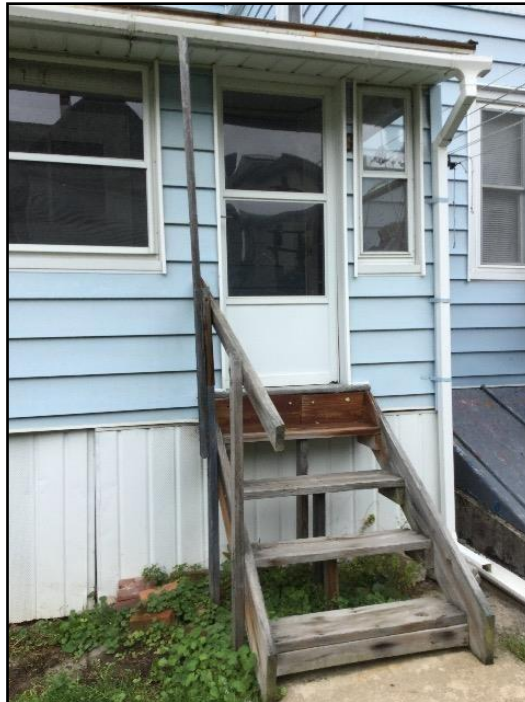
For additional Safety, Recommend installing left and right handrails and guardrails with spindles no more than 4 inches apart at open area. Also recommend installing wood on risers to obstruct children from squeezing through steps. Contact a contractor to further assess and advise.

29. Missing

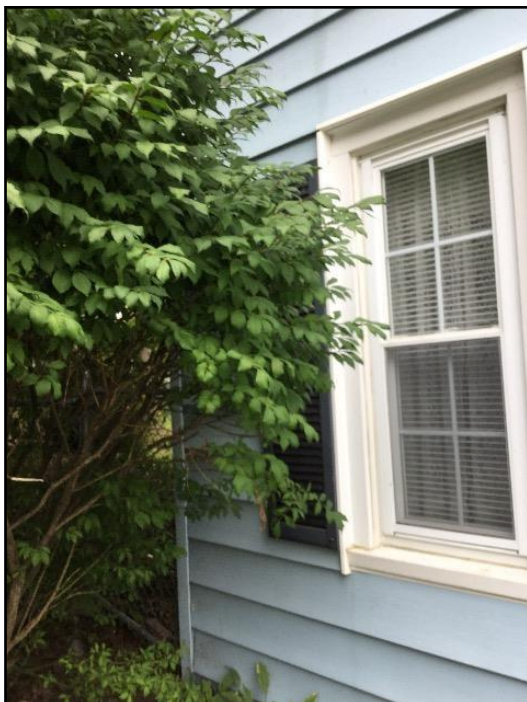
Maintenance: Observed trees/shrubs too close to exterior wall and roof. Recommend a landscaping contractor/arborist cut back.

30. Trees or shrubs too close to building

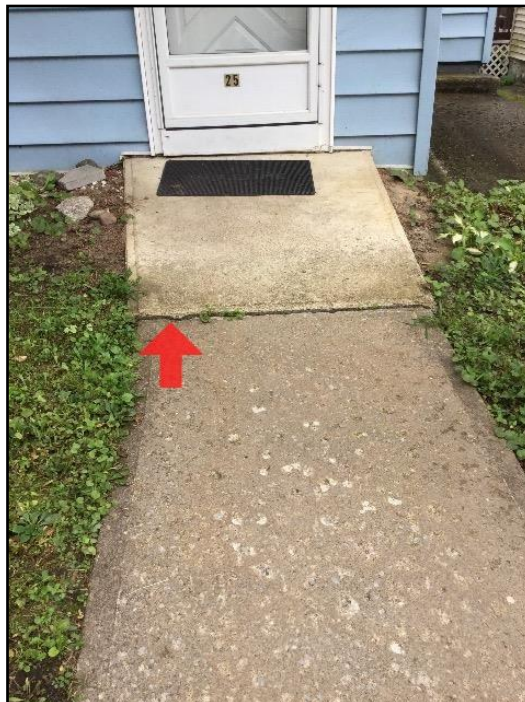
Concrete has moved creating a trip hazard. Recommend contact a contractor for options to minimize trip hazard.

33. Uneven (trip hazard)

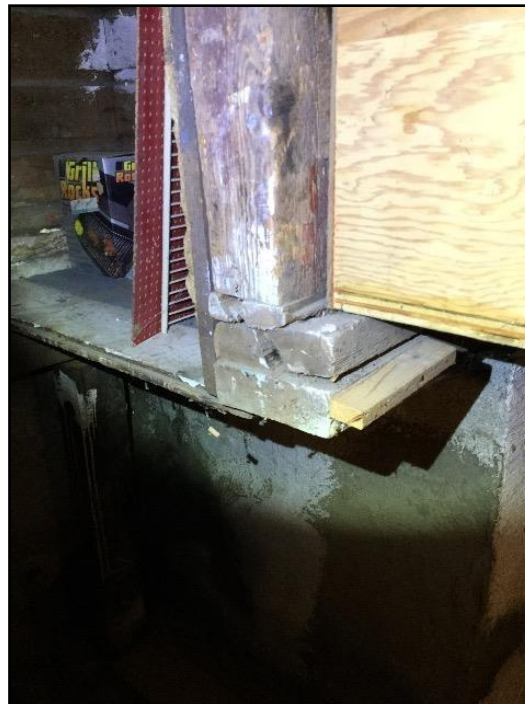
34.

**18. Condition:** • Possible cut support column for a joist. Have a contractor further assess.

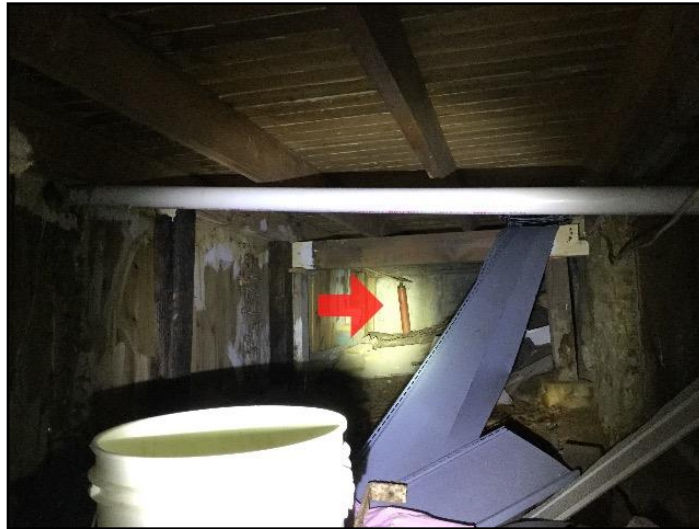
35. *Leaning*

Recommend having a contractor further assess and correct.

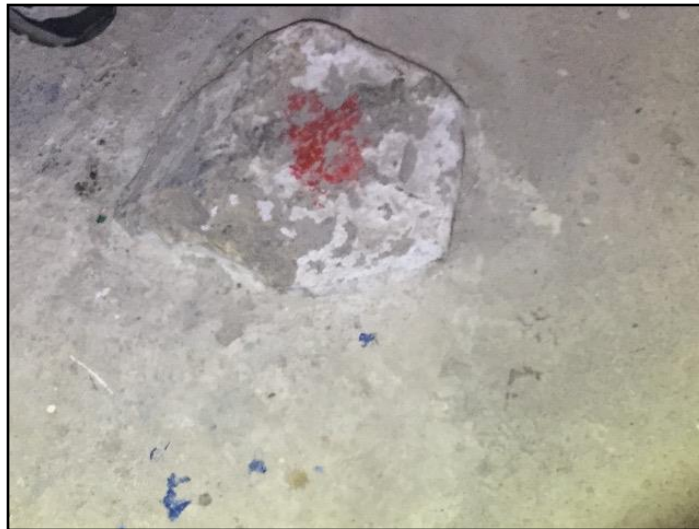
Appears a support column was removed/Pier still in place. Recommend a structural repair contractor is contacted to further assess and advise.

36. *Missing*

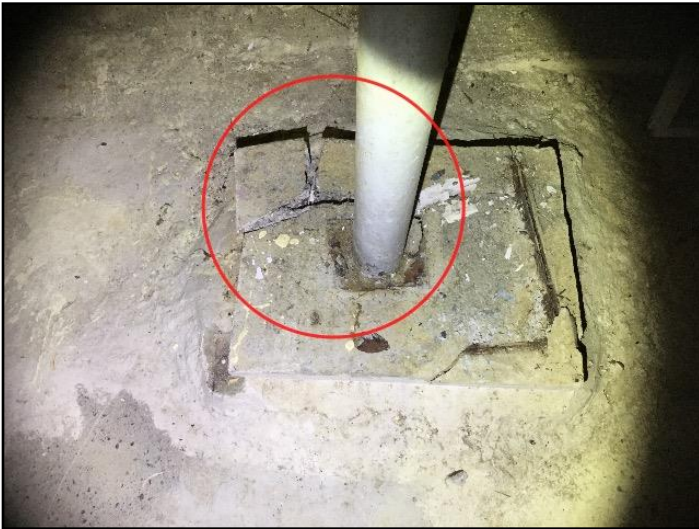
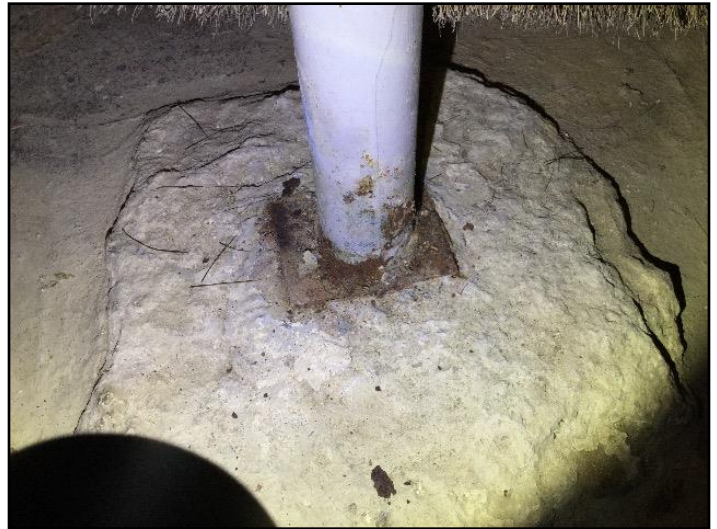
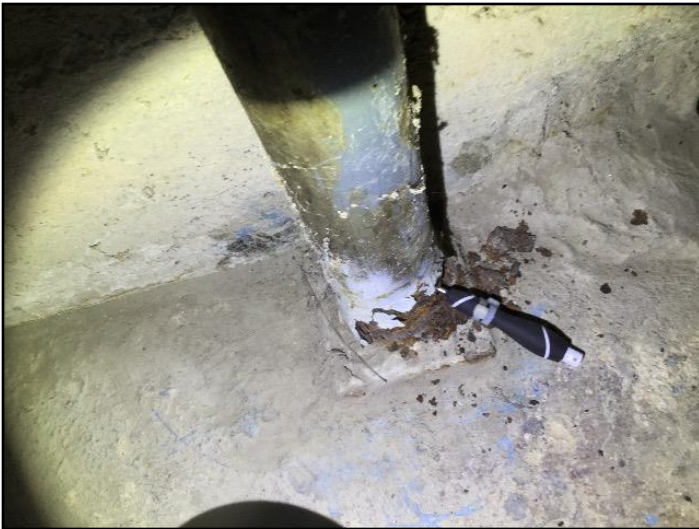
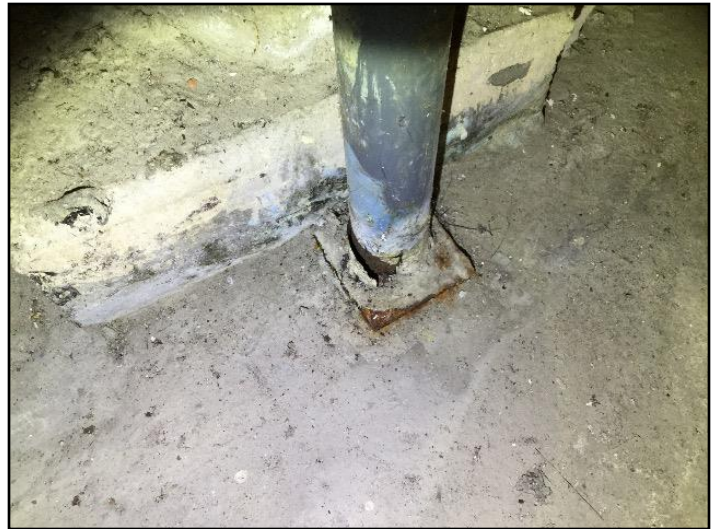
Observed one metal support column is severely rusted/rusted through at base and needs to be replaced. Also observed other metal columns with varying degrees of rust at base. One column had a damaged pier. Recommend a structural repair contractor further assess and advise.

37. Damaged Pier

38. Rust

39. Rotted Through at base

40. Rust

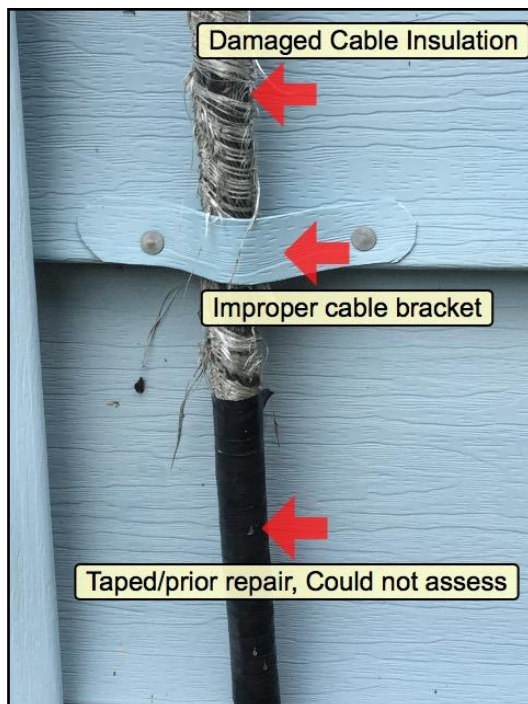
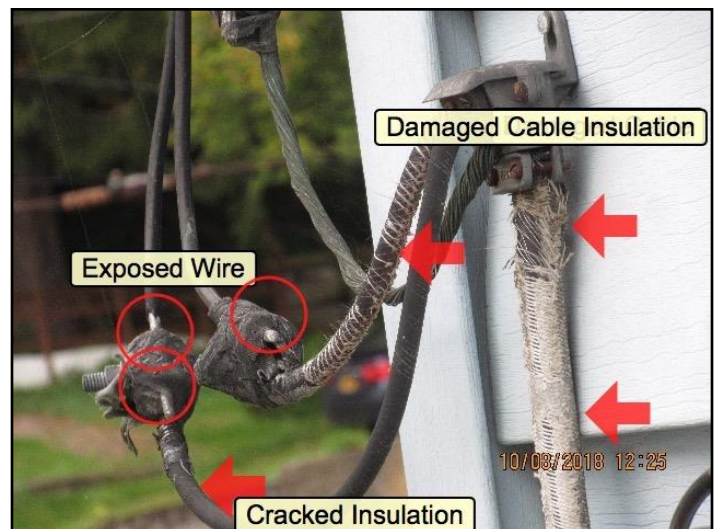
HAZARD: Cable appears to be worn/damaged/cracked and may need replacement. STRONGLY recommend a licensed electrician further assess and correct as needed, As Soon As Possible.

52. Conduit or cable damaged

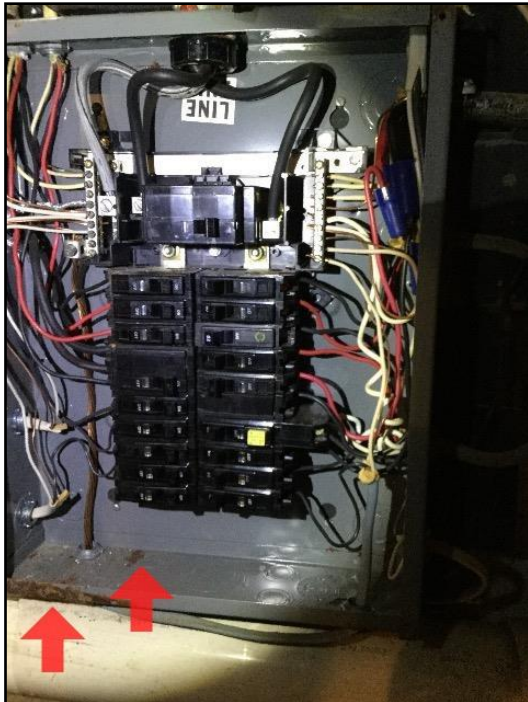
54. Service Box

Rust was observed in the service box and it appears to be coming from the meter which sits above it indicating the exterior service cable is/was not waterproof. Have a licensed electrician further assess and advise as soon as possible. Also See Service cable recommendations this section.

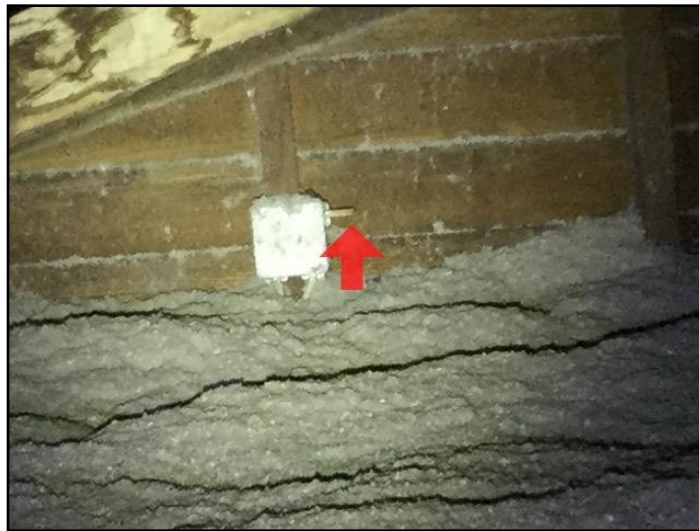
Observed an electrical wire which is not properly terminated in electrical box. (Potential Shock, Fire Hazard). Have licensed electrician correct as soon as possible.

60. Abandoned wire

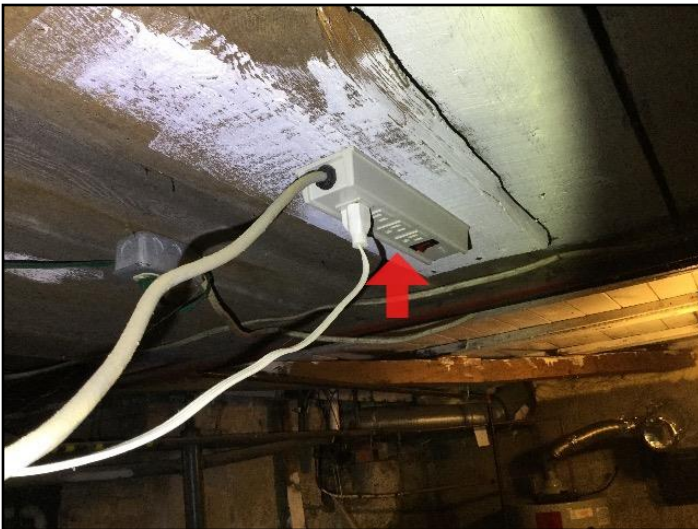
**SAFETY HAZARD:** Improper use of an Extension cord or wire. **STRONGLY** Recommend you contact a Licensed electrician to remove the extension wire and install another outlet nearer to the required point of use.

61. Extension cord used as permanent wiring

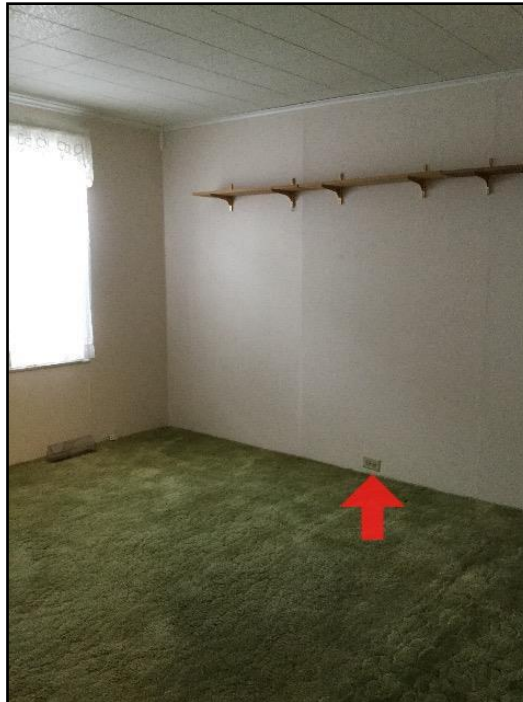
69. Living Room

Seven Ungrounded three prong outlets were observed. Although grounded outlets may not have been required at the time of construction, any 3 prong outlets should be grounded. Recommend contacting a licensed electrician to further assess and correct As Soon As Possible.

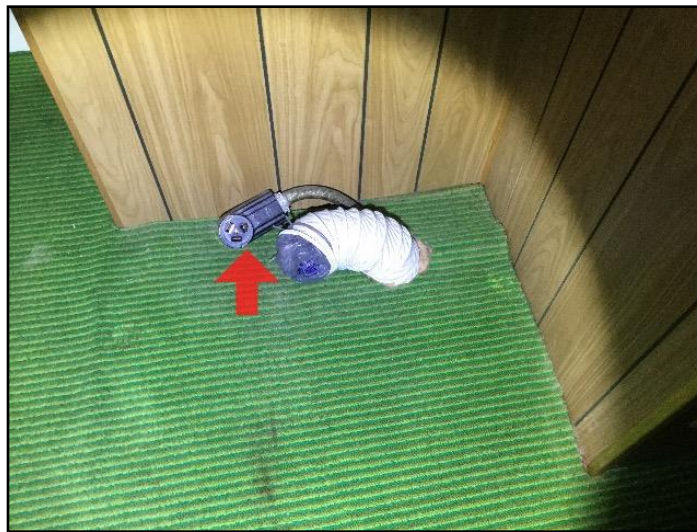
Outlet is loose/not secured to wall. Have licensed electrician repair as soon as possible.

70. Loose

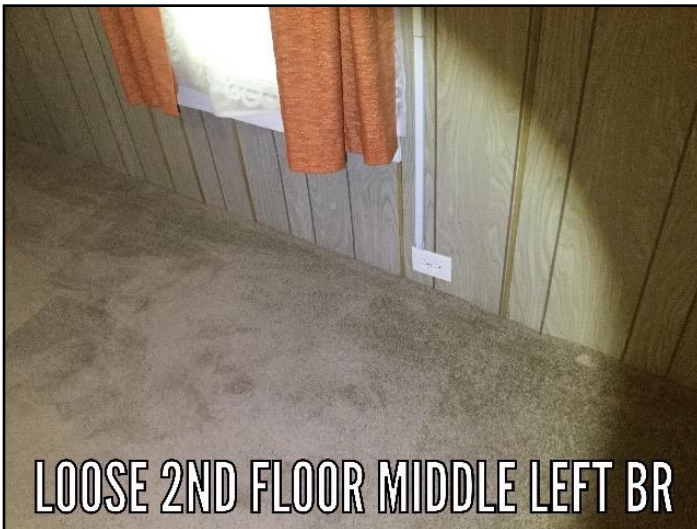
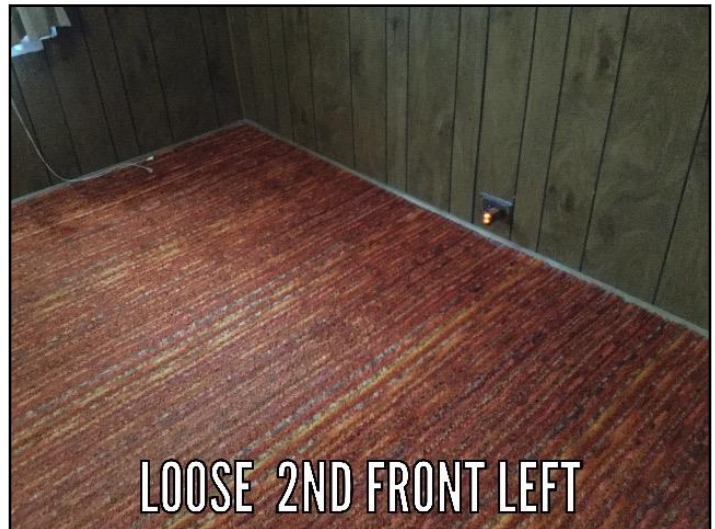
Outlet is loose. Have licensed electrician repair as soon as possible.

71. Loose

72. Loose

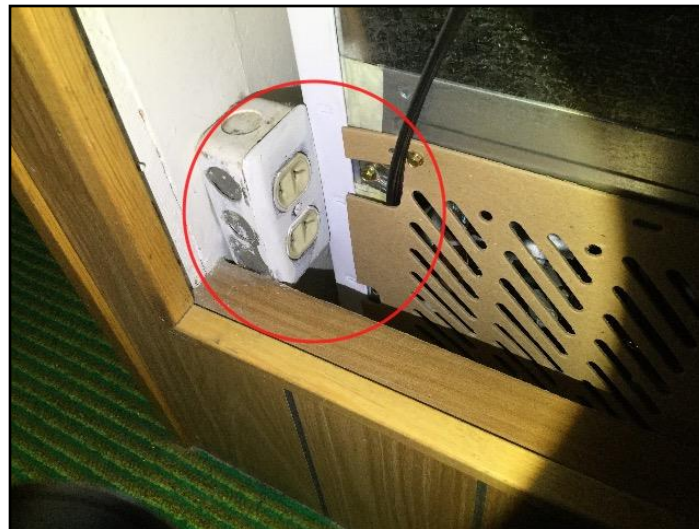
75. Outlet for refrigerator

**SAFETY:** Although not available/required at the time of construction., For additional Safety from electric shock: Recommend all Kitchen, bathroom, Rear Porch, basement, laundry outlets are upgraded to GFI protected circuits. Recommend a licensed electrician further assess and advise. Client should also consider AFCI/GFCI combination breakers for greater safety.

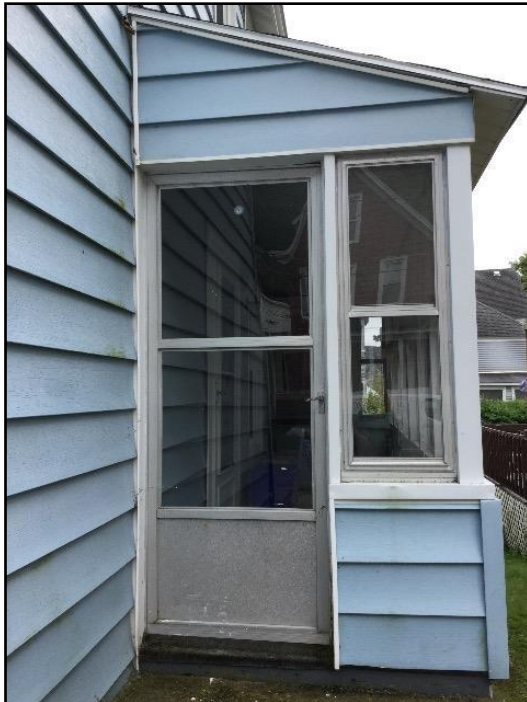
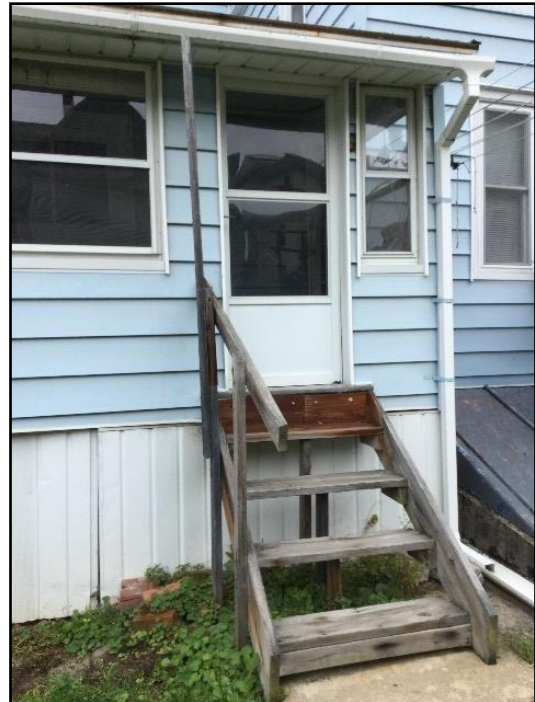
Light is missing. For added safety, Recommend a licensed electrician is contacted to install additional lighting to avoid injury.

**76. Missing**

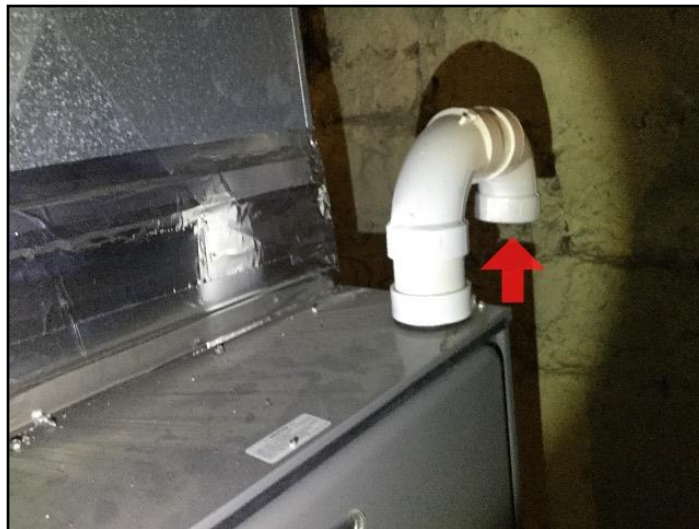
80.

**40. Condition:** • Recommend client consider extend the combustion air intake to the exterior of the building. Have an HVAC technician further assess and advise.

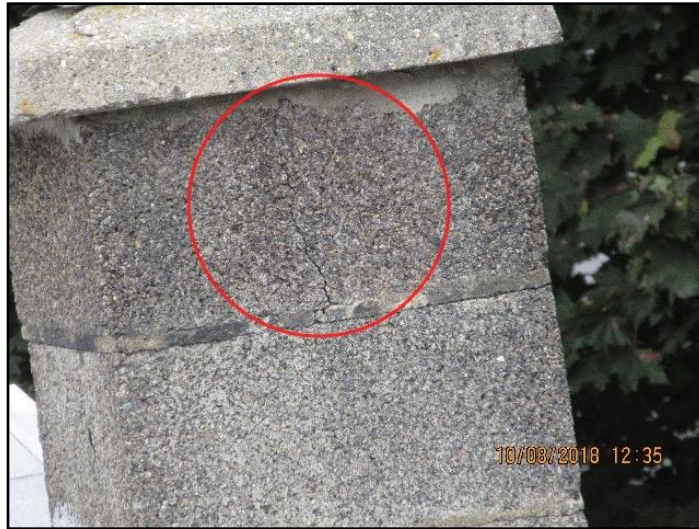
Chimney Block is cracked. Have a qualified chimney contractor further assess and repair as soon as possible. It appears the chimney is currently only being used to vent combustion gases from the water heater. Client may wish to upgrade the water heater to a direct sidewall vent and have the chimney removed or cut back at next roof replacement.

81. *Cracked*

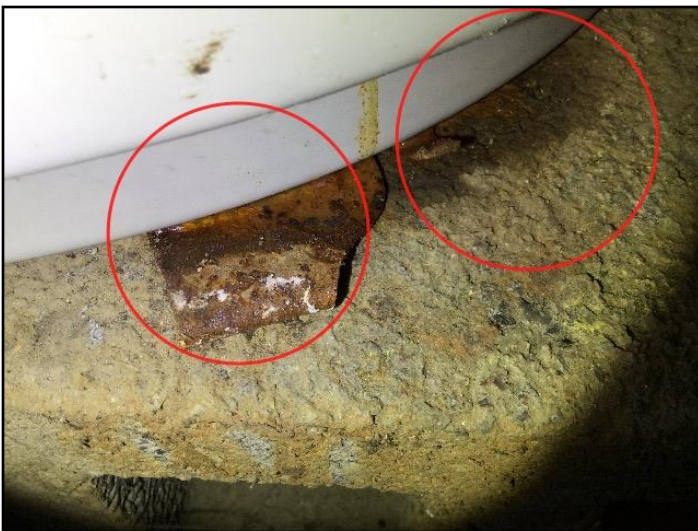
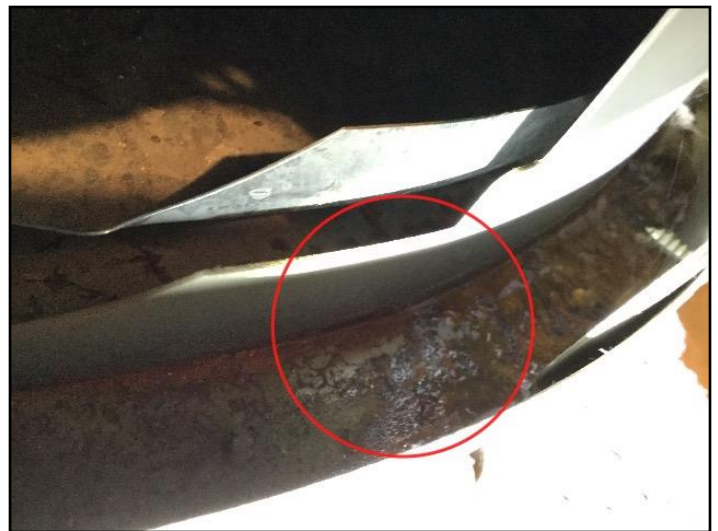
Observed water tank leaking at the base. Strongly recommend contacting a licensed plumber to further assess and advise.

85. Leak

86. Leak

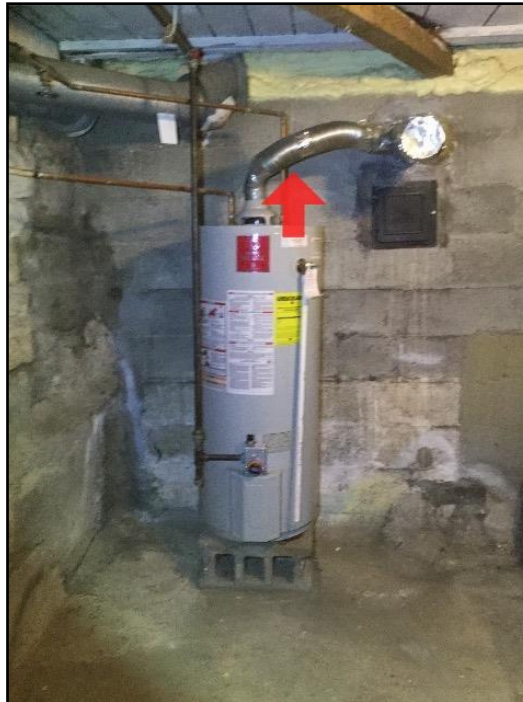
The aluminum material does not appear to be the proper venting material for a water heater. Recommend contacting a licensed plumber for further assessment and correct as needed.

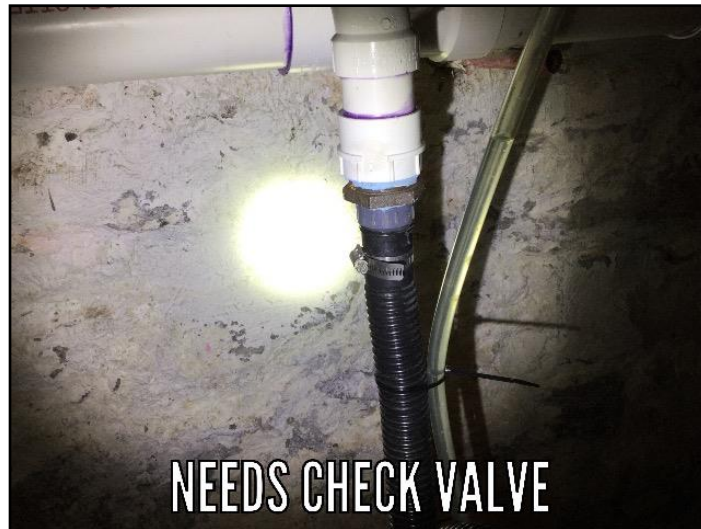
**44. Condition:** • Missing check valve  
Contact a licensed plumber to correct.

88. *Missing check valve*

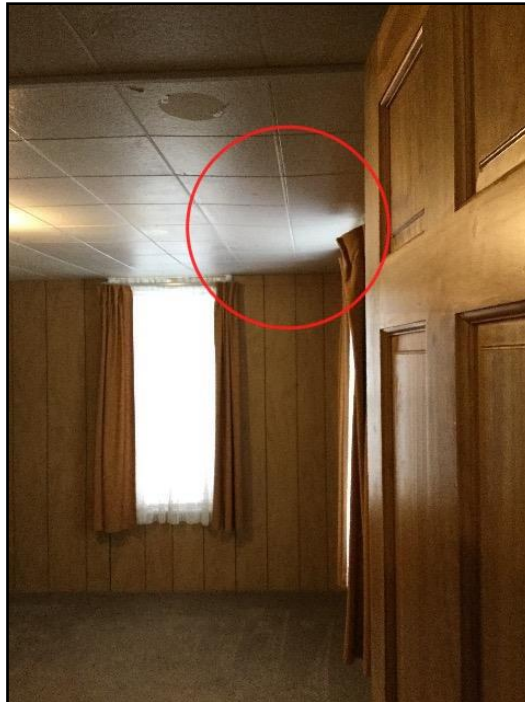
Sag in ceiling. Have a contractor repair

91. Loose sections

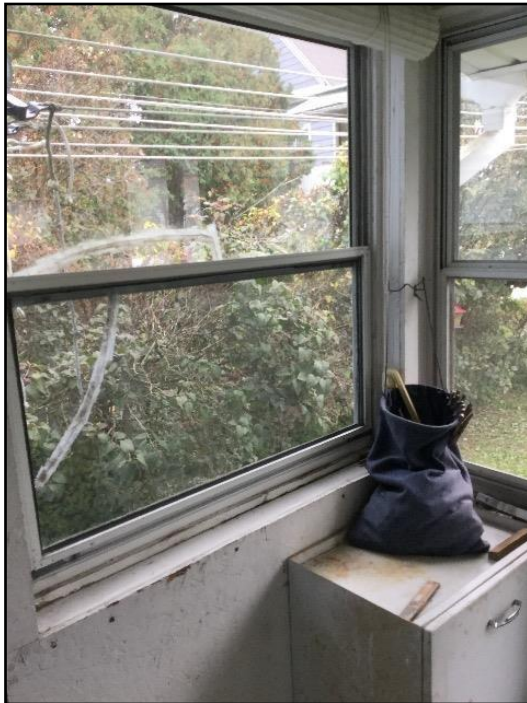
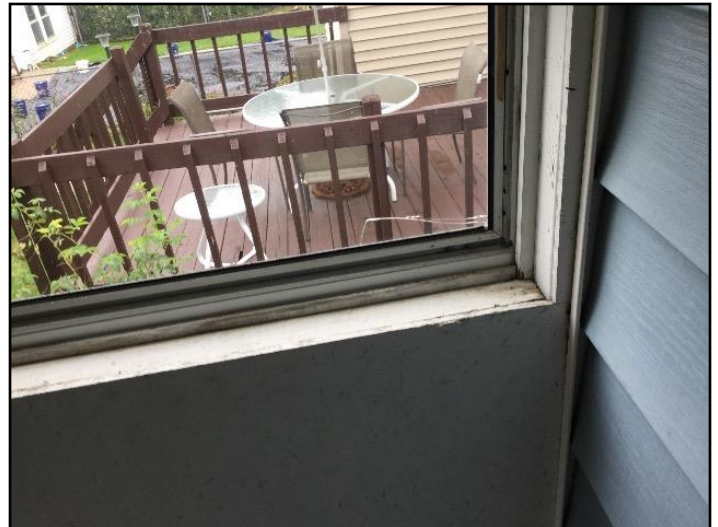
Observed 2 cracked storm window panes . Have a contractor replace.

92. Cracked

93. Cracked
