# Your Inspection Report

25 Lawrence St  
Little Falls, NY 13365

Monday, October 8, 2018

Report No. 1576, v.2

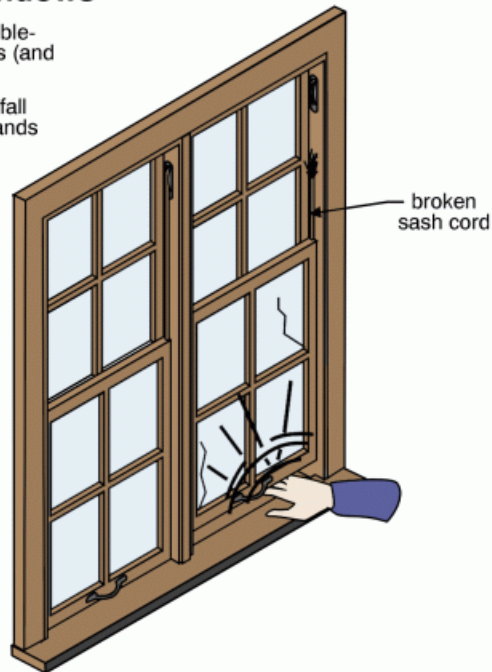
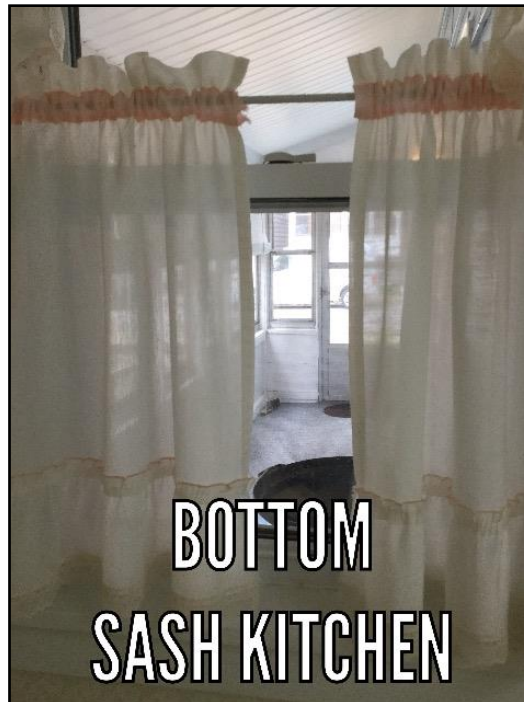
94. Won't stay open

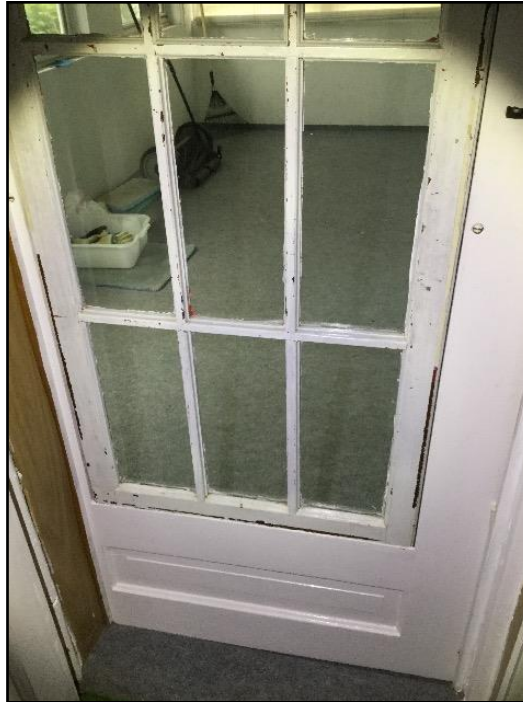
95. Rear Porch

**SAFETY:** Although may not have been required at the time of construction, For Additional Safety recommend door is upgraded to tempered glass to avoid injury.

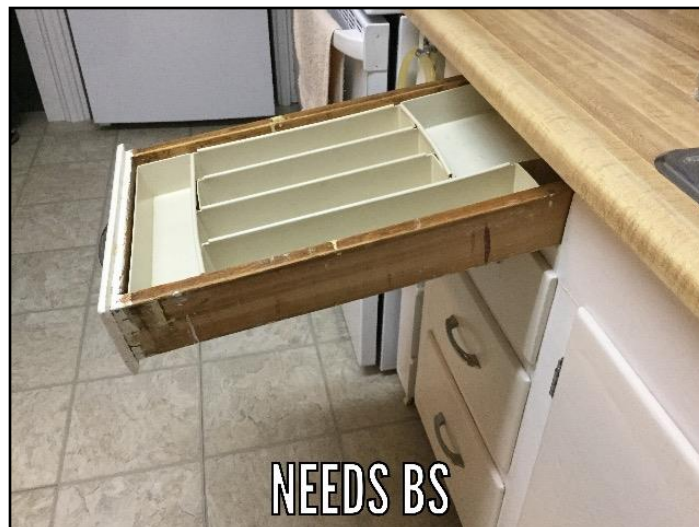
Cabinet drawer(s) do not have proper back stop allowing drawer to be pulled completely out falling on an adult or young child. Recommend installing back stops to avoid injury.

96. Drawers - missing or defective stops

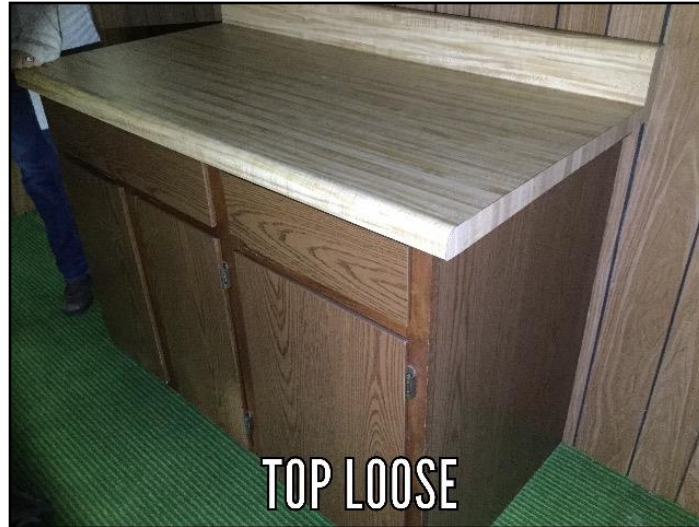
Countertop is loose or not attached. Have contractor secure to cabinet to avoid injury

97. Entire top loose

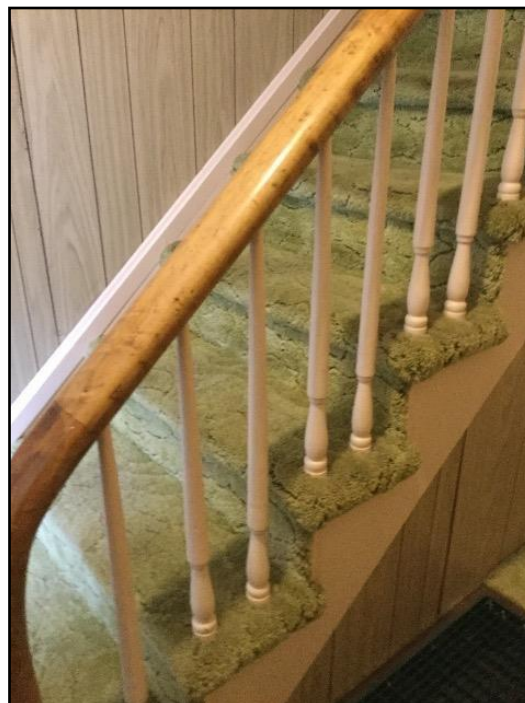
While it may have been acceptable at the time of construction, the handrail is lower than current recommended height. For added safety, (or at next renovation) client may want to consider raising the height to meet current recommended height.

98. Too low

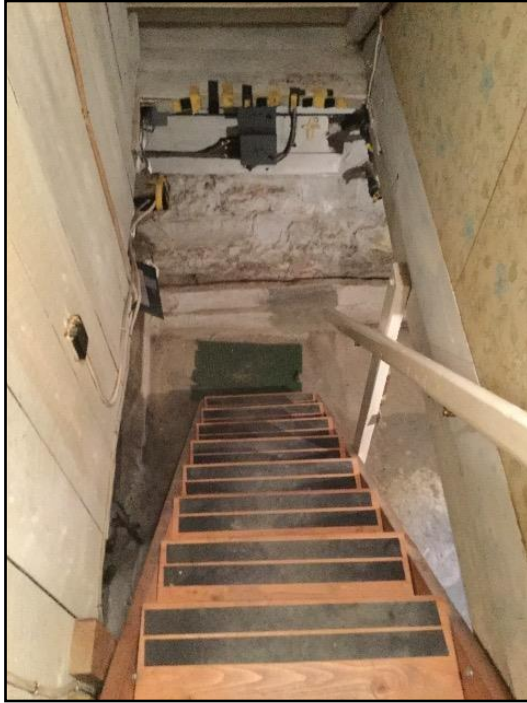
99. Basement

For added safety Recommend install handrails on each side of the stairs (with spindles no more than 4 inches apart at an open wall) to reduce the risk of trip/fall.

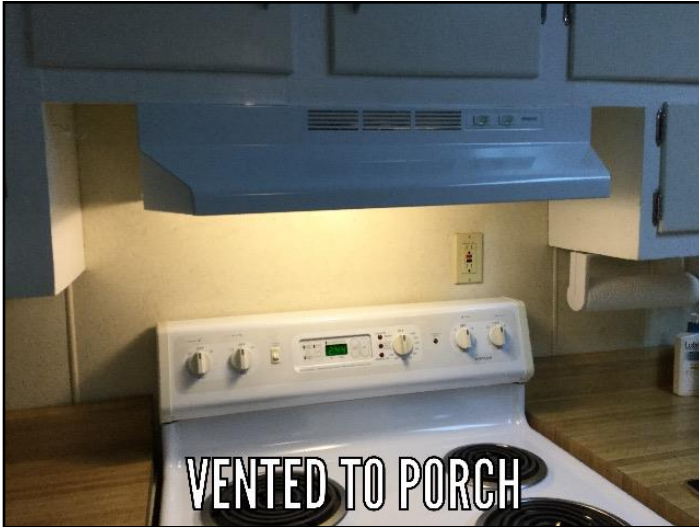
Kitchen Fan is venting directly into the enclosed porch, not exterior of home. To avoid damage to the interior of the enclosed porch, recommend reroute vent to the building exterior.

102. Not vented to exterior

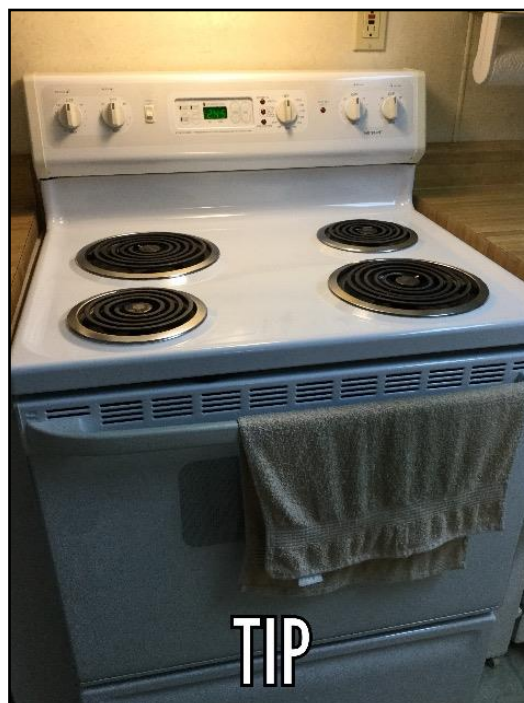
Recommend adding anti tip bracket to secure range to the floor thereby avoiding tipping and possible injury. Contact a contractor to correct.

104. Anti-tip device missing

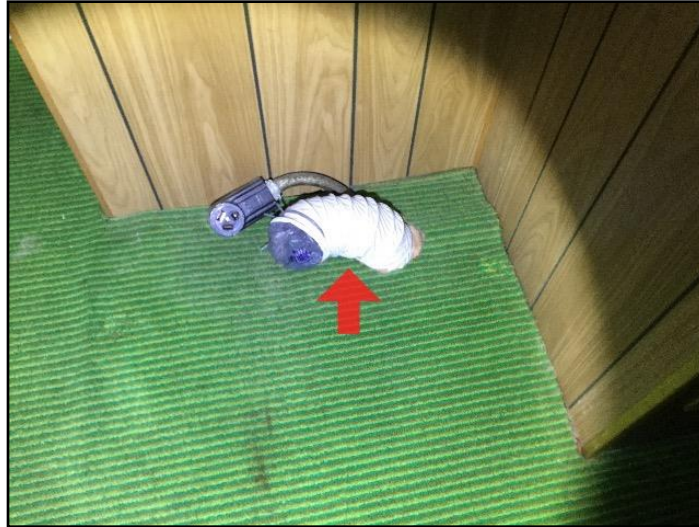
Should be replaced with semi-rigid or rigid metal piping to avoid fire hazard. Strongly recommend contacting a contractor to assess and correct as soon as possible.

**105.** *Plastic dryer vent*
