# Your Inspection Report

25 Lawrence St  
Little Falls, NY 13365

Monday, October 8, 2018

Report No. 1576, v.2

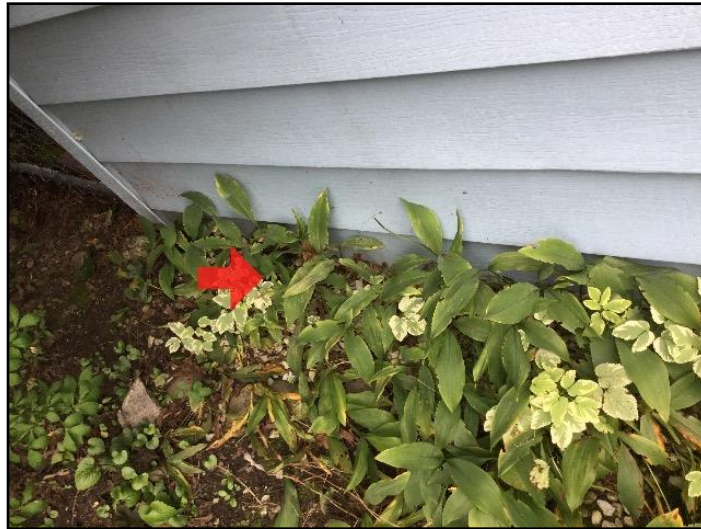
23. Too close to grade

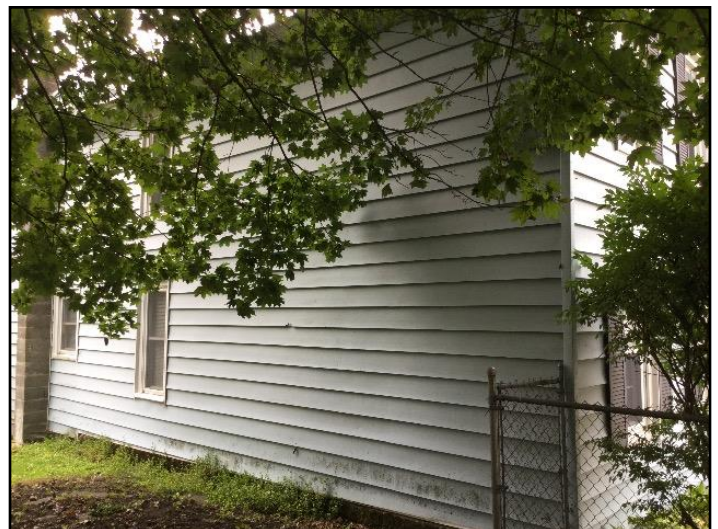
31. Trees or shrubs too close to building

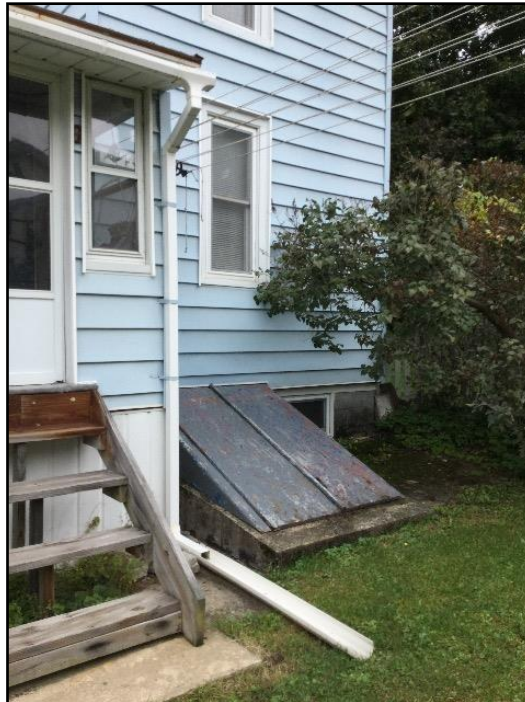
32. Trees or shrubs too close to building

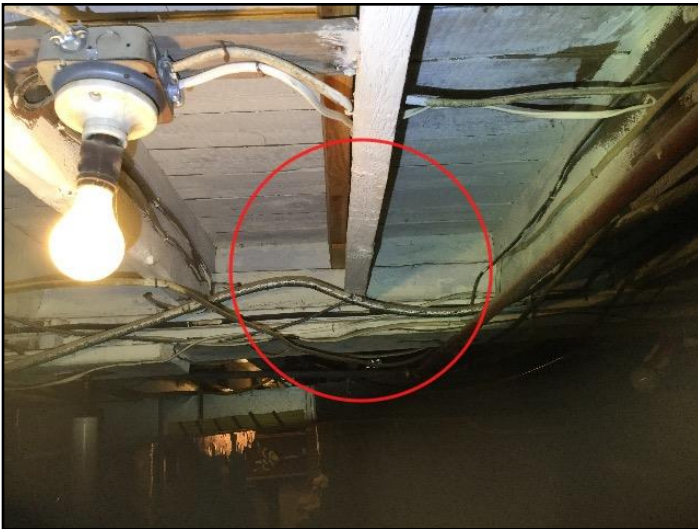
47. No blocking, bracing or bridging

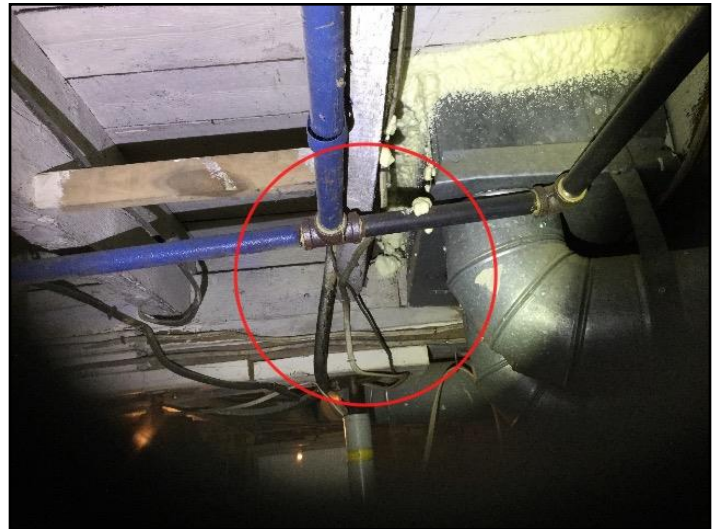
48. No blocking, bracing or bridging

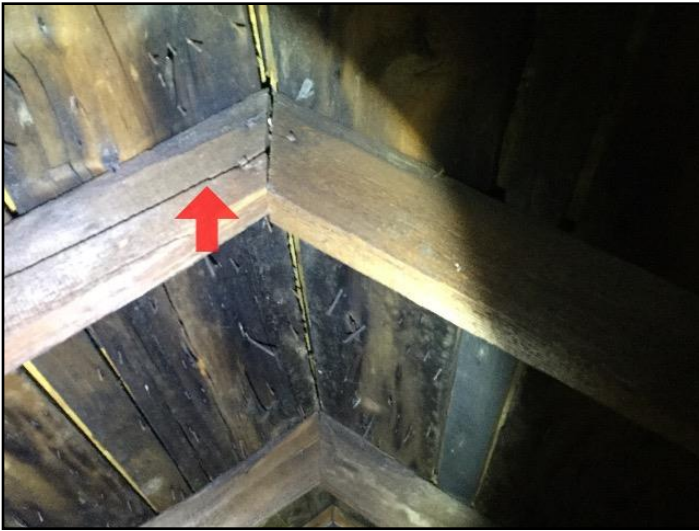
49. Split

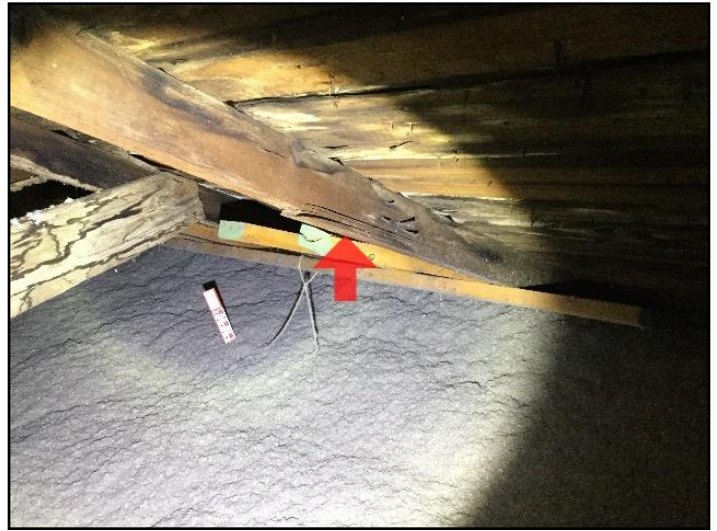
50. Split

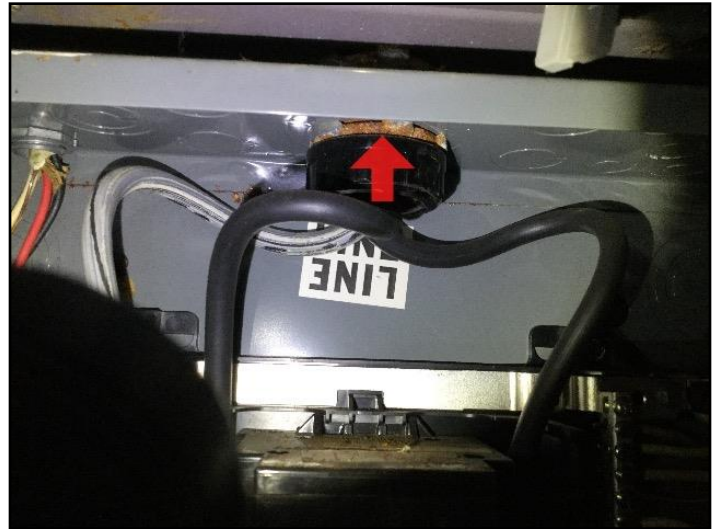
55. Service Box

Rust was observed in the service box and it appears to be coming from the meter which sits above it indicating the exterior service cable is/was not waterproof. Have a licensed electrician further assess and advise as soon as possible.

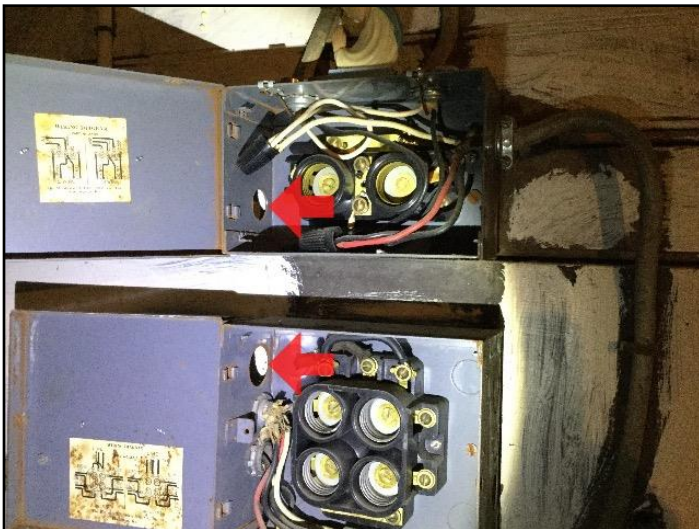
Unprotected opening/ knock-outs removed.. Have a Licensed electrician correct as soon as possible to avoid injury..

58. Openings in panel

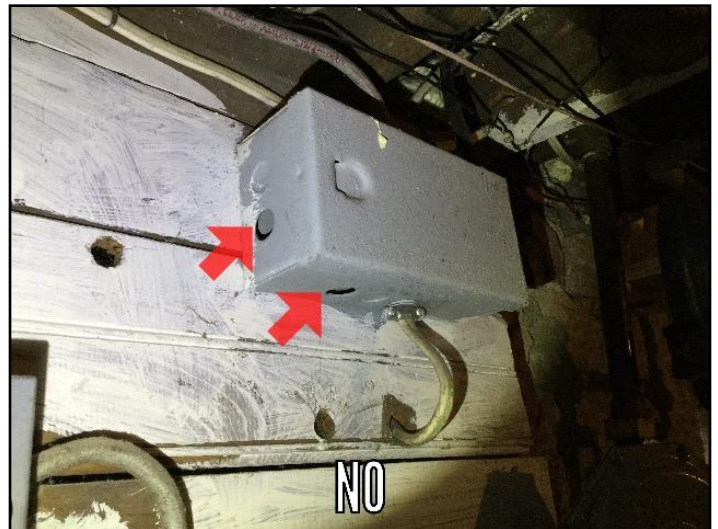
59. Openings in panel

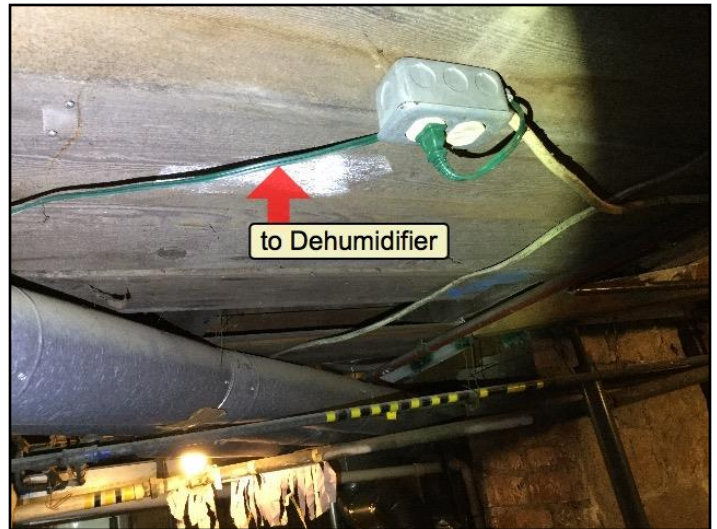
SAFETY HAZARD: Improper use of an Extension cord or wire. STRONGLY Recommend you contact a Licensed electrician to remove the extension wire and install another outlet nearer to the required point of use.

62. Extension cord used as permanent wiring

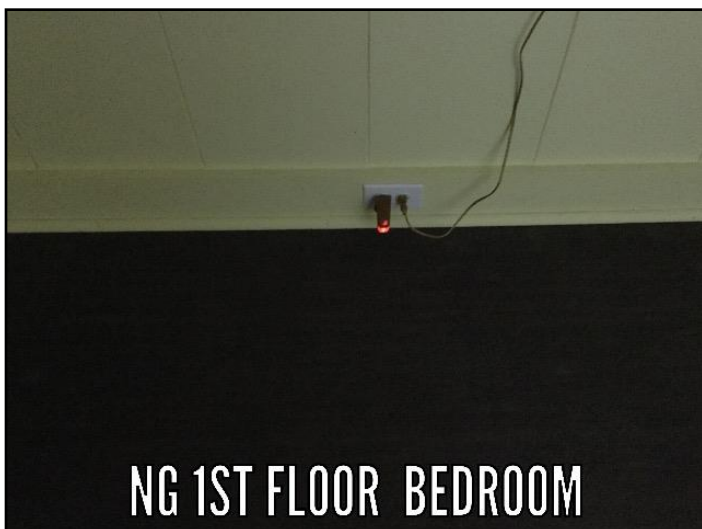
63. 1st floor bedroom

Seven Ungrounded three prong outlets were observed. Although grounded outlets may not have been required at the time of construction, any 3 prong outlets should be grounded. Recommend contacting a licensed electrician to further assess and correct As Soon As Possible.

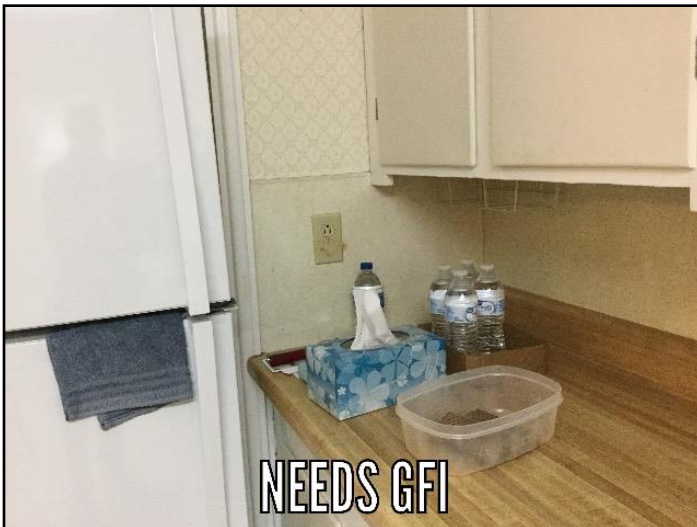
73. Kitchen

SAFETY: Although not available/required at the time of construction., For additional Safety from electric shock: Recommend all Kitchen, bathroom, Rear Porch, basement, laundry outlets are upgraded to GFI protected circuits. Recommend a licensed electrician further assess and advise. Client should also consider AFCI/GFCI combination breakers for greater safety.

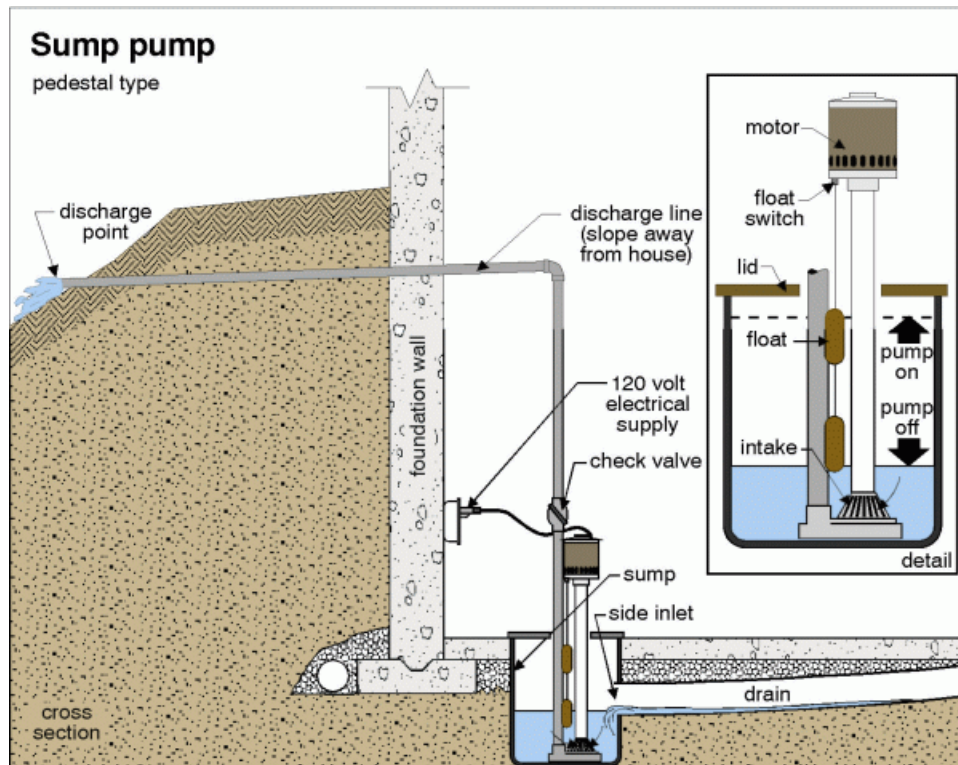
88. *Missing check valve*

**44. Condition:** • Missing check valve  
Contact a licensed plumber to correct.

**Location:** Basement

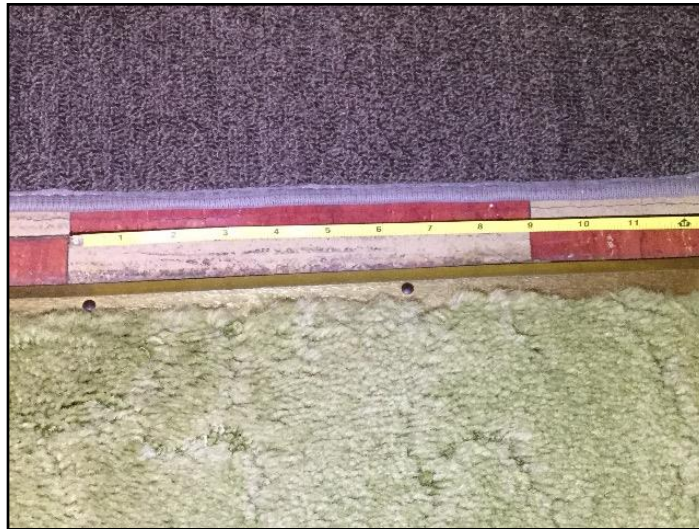
90.

47. • Client should be aware 9X9 tiles were observed under the first floor bedroom carpet. This size tile are suspected to contain asbestos. None were observed to be damaged. If client is considering renovation which includes damage to or removal of the tiles client should ensure a licensed NYS mitigation contractor is used.

**Implication(s):** Asbestos Contamination

**Location:** First Floor Bedroom

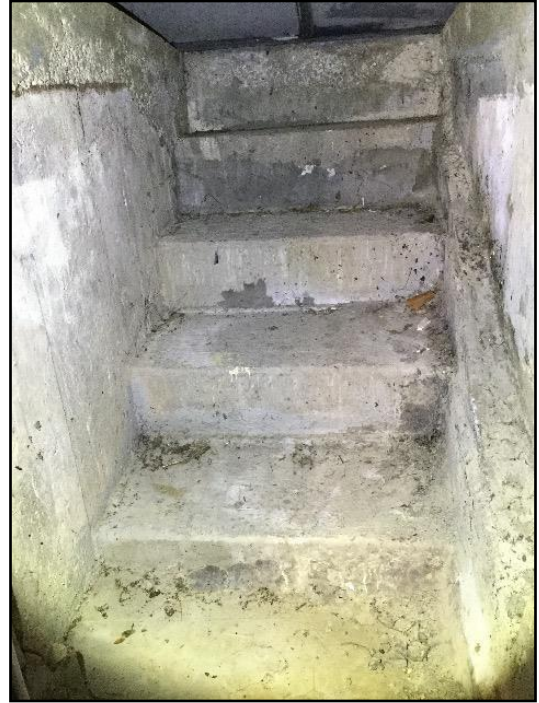
100. Basement Walkout

## 55. Condition: • Missing

For added safety Recommend install handrails on each side of the stairs (with spindles no more than 4 inches apart at an open wall) to reduce the risk of trip/fall.

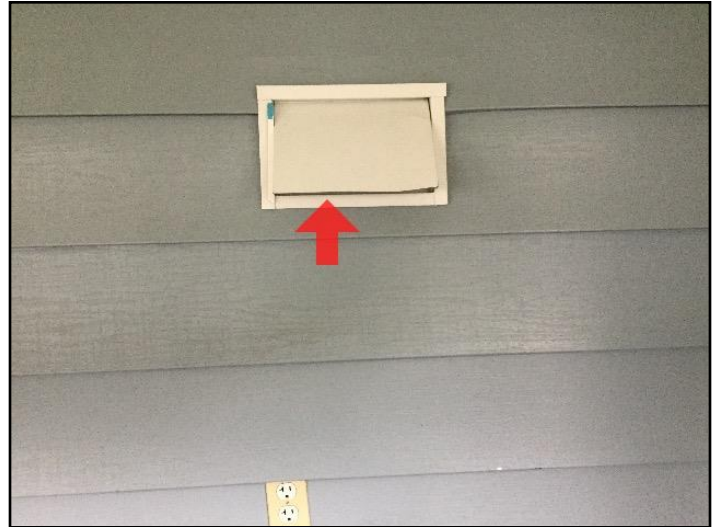
103. Not vented to exterior

**56. Condition:** • Not vented to exterior

Kitchen Fan is venting directly into the enclosed porch, not exterior of home. To avoid damage to the interior of the enclosed porch, recommend reroute vent to the building exterior.
